DEPARTMENT OF TRANSPORTATION

Office of Structural Materials

Contract #: 04-0120F4Cty: SF/ALA Rte: 80 PM: 13.2/13.9File #: 1.28**WELDING INSPECTION REPORT****Resident Engineer:** Casey, William**Address:** 333 Burma Road**City:** Oakland, CA 94607**Report No:** WIR-028614**Date Inspected:** 19-Oct-2012**Project Name:** SAS Superstructure**OSM Arrival Time:** 700**Prime Contractor:** American Bridge/Fluor Enterprises, a JV**OSM Departure Time:** 1730**Contractor:** American Bridge/Fluor Enterprises, a JV**Location:** Job Site

Bridge No: 34-0006 **Component:** SAS OBG

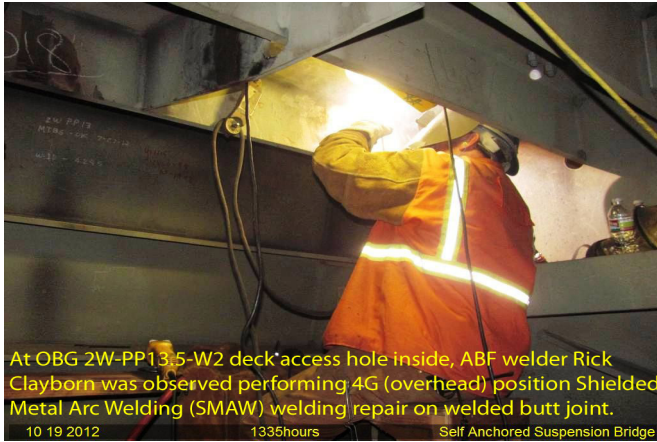
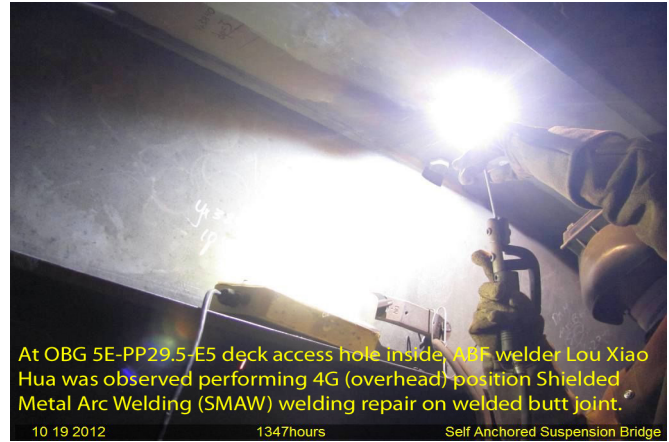
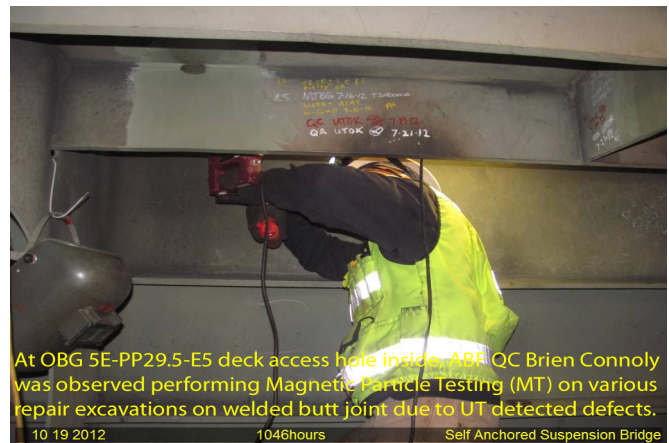
At OBG 5E-PP-29.5-E5 deck access hole inside, QA randomly observed ABF/JV qualified welder Lou Xiao Hua perform CJP groove welding repair. The welder was observed welding in the 4G (overhead) position utilizing Shielded Metal Arc Welding (SMAW) with 3.2mm diameter E7018H4R electrode implementing welding procedure ABF-WPS-D15-1001-Repairs. The repair excavation was preheated to more than 150 degree Fahrenheit using propane gas torch prior welding. During the shift, ABF QC Barry Drake was noted monitoring the welder. Prior welding, ABF QC Brian Connolly was also observed performing Magnetic Particle Testing (MT) on the repair excavations prior welding repair. There were no significant defects noted during the test. The following second time repairs were noted excavated and welded during the shift;

At OBG 2W-PP13.5-W2 N deck access hole inside, QA randomly observed ABF/JV qualified welder Ric Clayborn perform CJP groove welding repair due to UT detected defect and heat transfer mark using oxy-propylene gas torch. The welding repair is being performed on three (3) various locations per Caltrans approved Request for Weld Repair (RWR) # 201209-114 through 116. The welder was observed welding in the 4G (overhead) position utilizing Shielded Metal Arc Welding (SMAW) with 3.2mm diameter E7018H4R electrode implementing welding procedure ABF-WPS-D15-1000-Repairs. The repair excavations were excavated using carbon air arc gouging with preheat temperature of more than 150°F using propylene gas torch prior excavation. The groove of the excavation was ground smooth and tested by ABF QC Salvador Merino using Magnetic Particle Testing (MT). During welding repair, the repair area and its vicinity was preheated to more than 150 degree Fahrenheit using propylene gas torch prior/during welding. During the shift, ABF QC Salvador Merino was noted monitoring the welder with measured working current of 135 amperes on 3.2mm E7018H4R electrode. At the end of the shift all three excavations from the bottom were completed. However, contractor's recommended WPS to be used (listed in the RWR) during welding repair were not implemented due to non-conformity to the joint configuration and this was brought to the attention of Lead QA Rodney Patterson. The following repairs were noted excavated and welded from the bottom during the shift;

At OBG location Panel Point PP114 through PP116, this QA randomly observed FW Spencer qualified welder Damian Llanos continuing to perform Complete Joint Penetration (CJP) 6G (all position) Shielded Metal Arc Welding (SMAW) welding root pass to cover pass on 2 1/2" diameter domestic utility water, 4" diameter compressed air lines and 1" diameter weldolet. The welder was noted welding the root pass with 3/32" diameter E6010 electrode and followed by fill pass to cover pass using 3/32" diameter E7018H4R electrode implementing Caltrans approved procedure FW Spencer WPS 1-12-1. The welder was noted preheating and removing the moisture of the joint using a portable propane gas torch prior welding. During welding, ABF QC Steve Jensen was noted monitoring the parameters of the welder. At the end of the FW Spencer shift, CJP welding on one 2 1/2", one 4" and two 1" diameter utility water, compressed line pipe butt joints and weldolet T-joints respectively were completed.
